## RISK ASSESSMENT IN 13-STORY BUILDING PROJECTS WITH THE FAILURE MODE AND EFFECT ANALYSIS (FMEA) METHOD AND THE DOMINO EFFECT

Salman Farid Lahmadi, Betanti Ridhosari, I Wayan Koko Suryawan, Ariyanti Sarwono

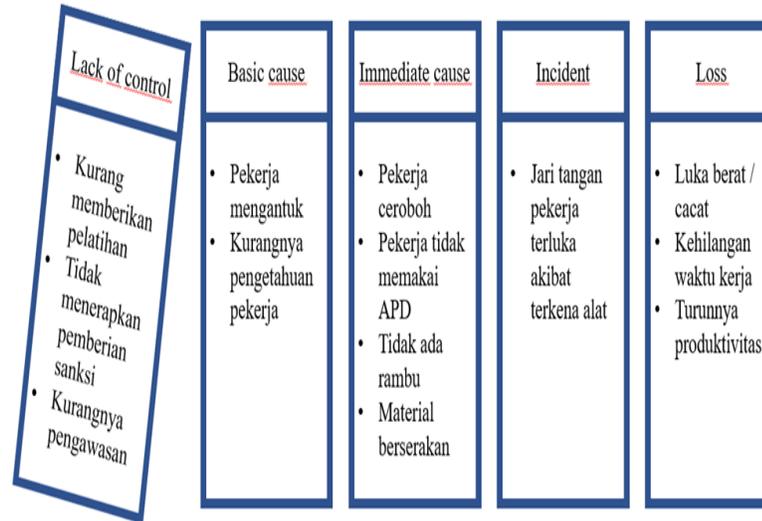
Figure 1. An overview of the results of the domino method analysis

Lack of control does not provide training to workers, does not apply sanctions, and lack of supervision can lead to basic causes, namely sleepy workers and lack of knowledge of workers about good and safe working methods. The basic cause resulted in an immediate cause: the workers were

careless and did not wear personal protective equipment. As a result of the immediate cause in the form of an incident, the worker's finger is injured due to being hit by a tool so that it creates a loss in the form of

serious injury/disability, lost work time, and decreased productivity. Figure 1 is an arrangement of dominoes which if one card falls, a domino effect will occur so that it overwrites the other cards.
